CASE REPORT

Management of Instrument Separation: A Case Series

Conservative Dentistry and Endodontic Journal (2019): 10.5005/jp-journals-10048-0049

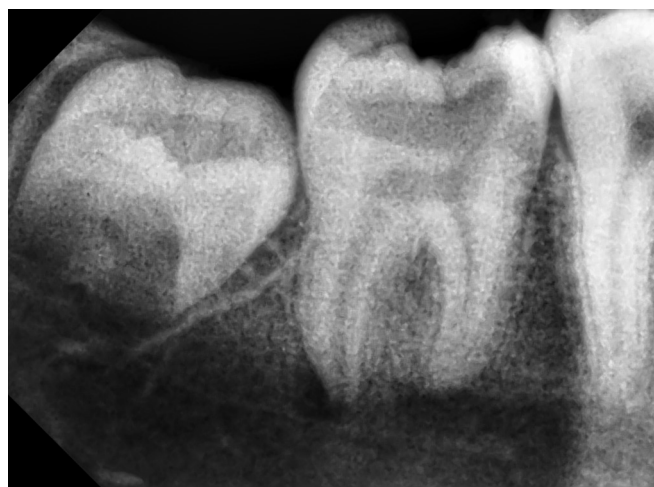
A 14-year-old female patient reported to the department of conservative dentistry and endodontics with the complaint of pain in lower right back tooth since 2 days. After clinical and radiographic examination, case was diagnosed as symptomatic irreversible pulpitis with apical periodontitis in relation to 47 (Fig. 1).

Fig. 1: Preoperative radiograph

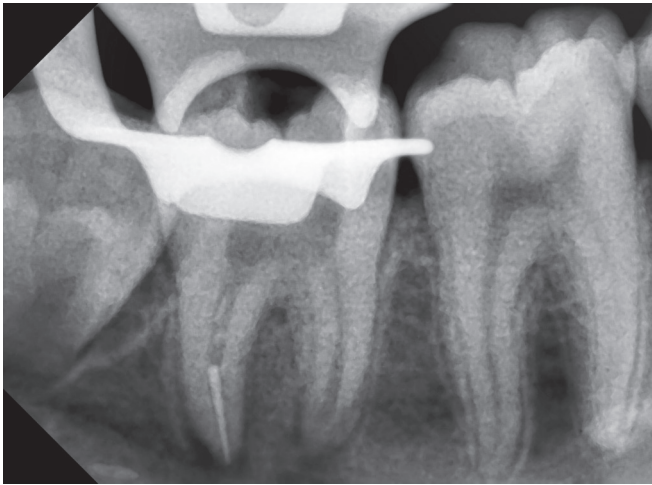
Fig. 2: Fractured F2 in apical third

got separated. Radiograph revealed that the fractured segment was in the apical third of distal canal of 47 (Fig. 2). The fractured segment was viewed under dental operating microscope (Fig. 3). K files were sequentially used to bypass the separated file (Fig. 4). Attempting to retrieve the segment further pushed it beyond the apex (Fig. 5). The Woodpecker ultrasonic system with ultrasonic U file no. 20 and no. 25 size (Fig. 6) was used at low power setting and made to contact the fractured instrument and vibrate. Ultrasonically activated files with water coolant were used to loosen the fragment from the inner dentin. Intermittent irrigation was done with normal saline. Once the instrument was set loose within the canal, the instrument was flushed out with normal saline. Radiograph was taken to confirm removal of instrument (Figs 7 and 8). Obturation was completed on subsequent appointment (Fig. 9)

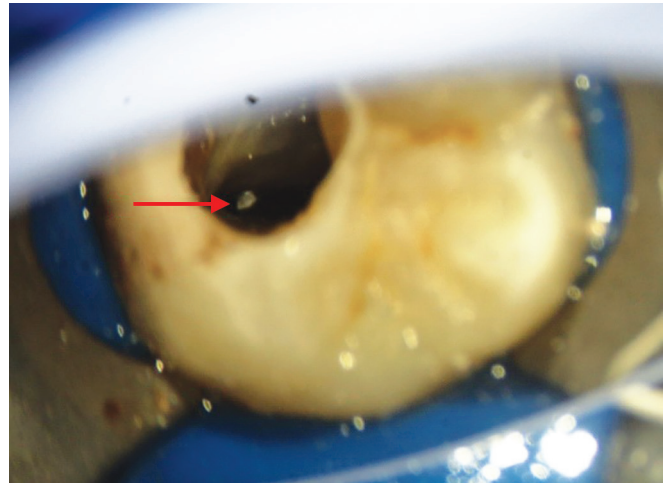
Fig. 3: Microscopic view of fractured file in distal canal marked by red arrow

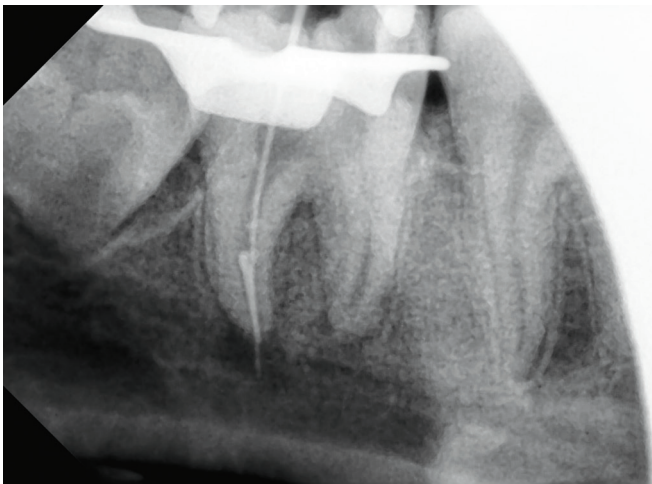
Fig. 4: Bypassed up to no. 20 size K file

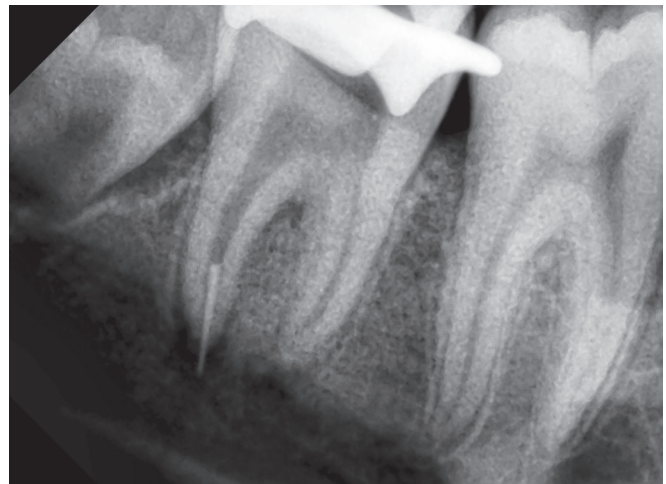
Fig. 5: File pushed beyond apex

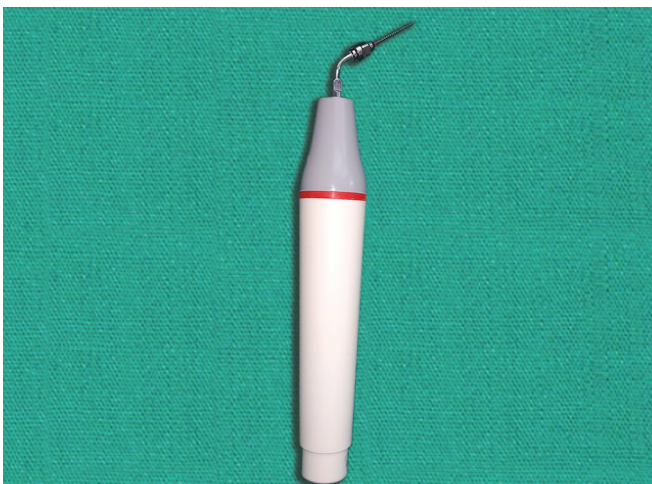
Fig. 6: Ultrasonic handpiece with file attached

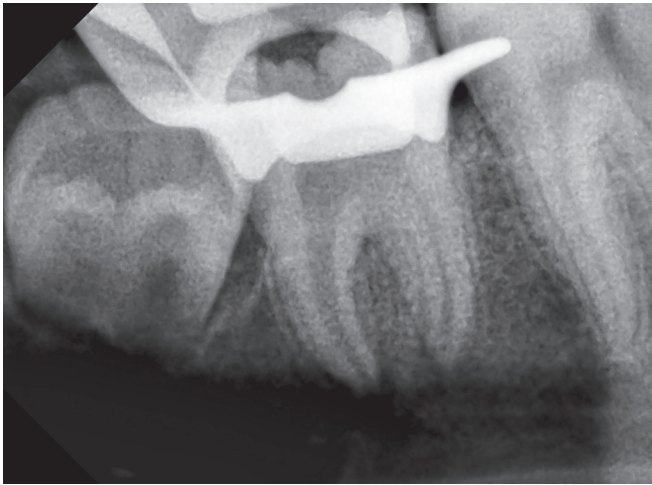
Fig. 7: Radiograph after removal of separated instrument

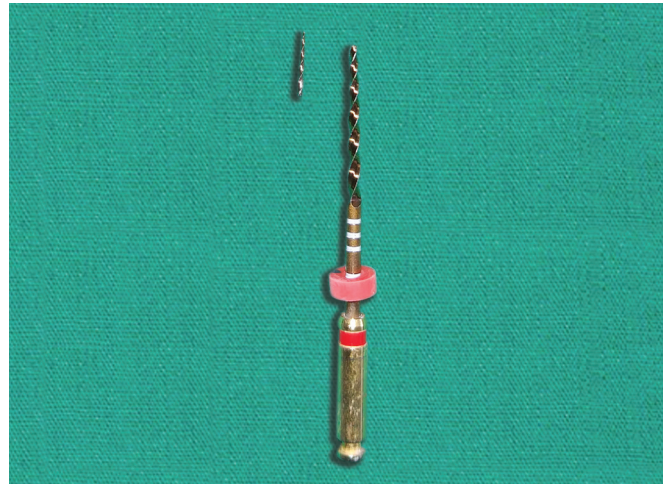
Fig. 8: Fractured file F2 with its fragment

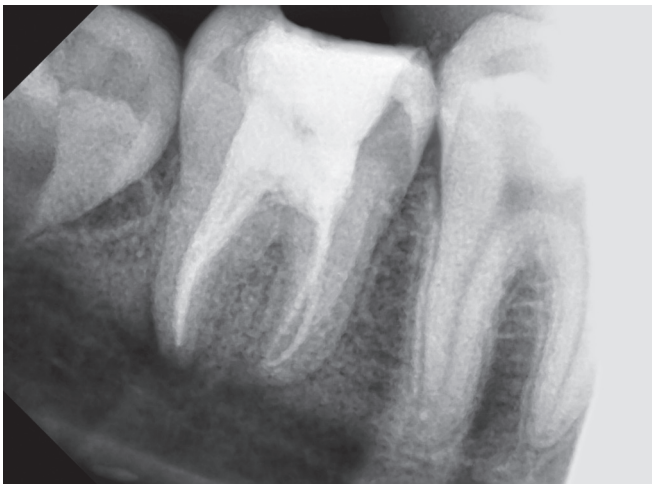
Fig. 9: Postobturation radiograph

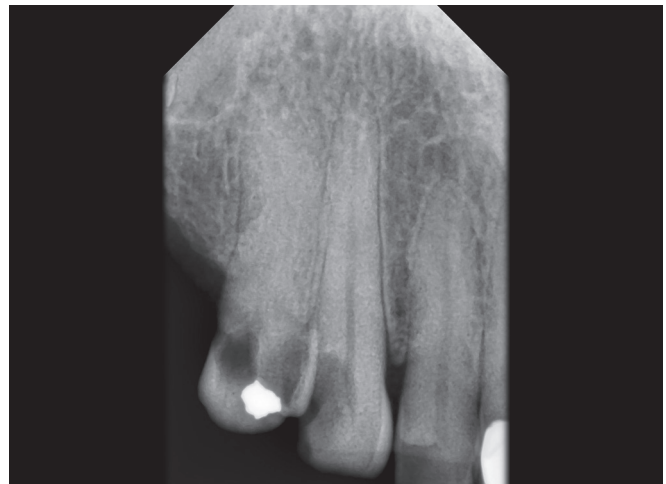
Fig. 10: Preoperative radiograph

radiolucency was seen on distal aspect of 13 suggestive of deep caries, no periapical changes noted (Fig. 10). Case was diagnosed as symptomatic irreversible pulpitis with apical periodontitis in relation to 13. Root canal treatment was planned for 13 and 14.

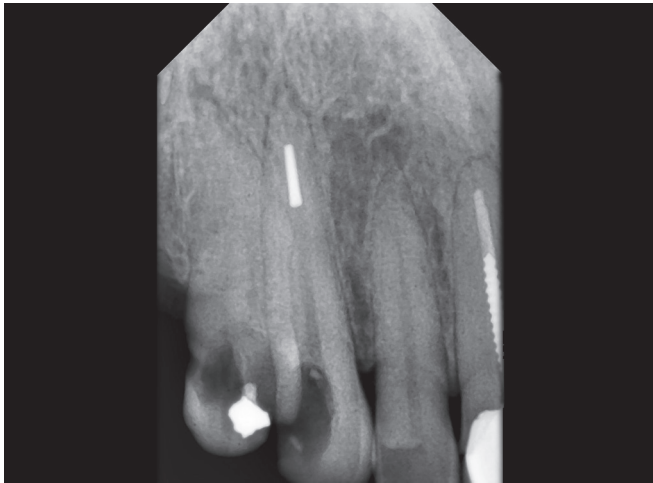
On the first visit, root canal treatment was initiated on 13 under local anesthesia and rubber dam isolation, access cavity prepared and biomechanical preparation completed. On second visit, during access cavity refinement there was an accidental breakage of the 169L tungsten carbide bur within the tooth. While trying to remove the separated bur, it was pushed further toward the apex. Radiograph revealed that bur was at the junction of middle and apical third of the root canal. The fractured segment in the canal was about 2.5 mm long (Fig. 11)

Fig. 11: Separated bur head within the canal

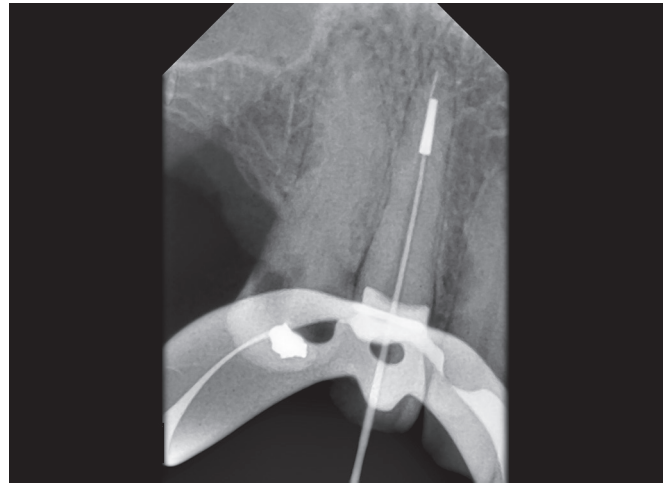
Gentle and careful instrumentation enabled the fragment to be bypassed with K-file up to 20 size to the full working length (Fig. 12). Retrieval was tried with indirect ultrasonic vibrations applied to the handle of bypassed K-file, but it failed to deliver the instrument out of the canal. Two new Headstrom files of size 15 and 25 were used to bypass the bur fragment buccally and lingually and were engaged as deep as possible, twisted clockwise using the file braiding technique. Braiding of these files and a short outward pull resulted in the instrument being removed from the canal (Figs 13 and 14). Radiograph was taken to confirm

Fig. 12: Bypassed with no. 20 size K-file

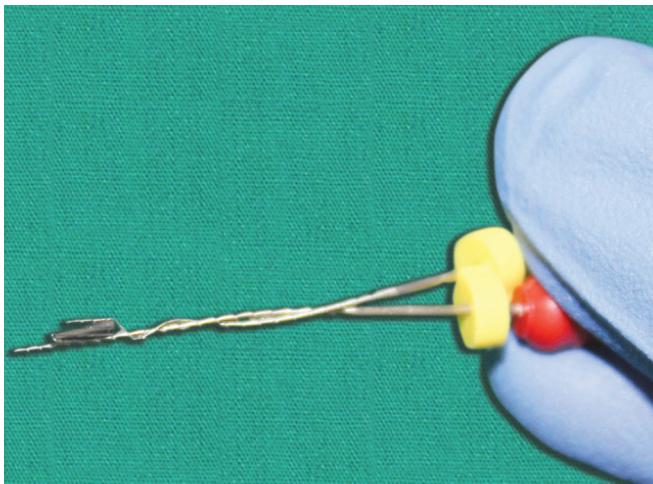
Fig. 13: Braided H-files with fractured bur head

In the second case, it was possible to bypass the fractured instrument; hence, there was greater chances for retrieval with braiding technique. Braiding is a simple technique that can be used to remove fractured instruments from deeper in the root canal. In file-braiding technique, two or three different sizes of new H-files were gently screwed into the canal alongside of the fragment, wound around each other and withdrawn together with an outward stroke.¹⁶ The object should be gripped by the files and removed.

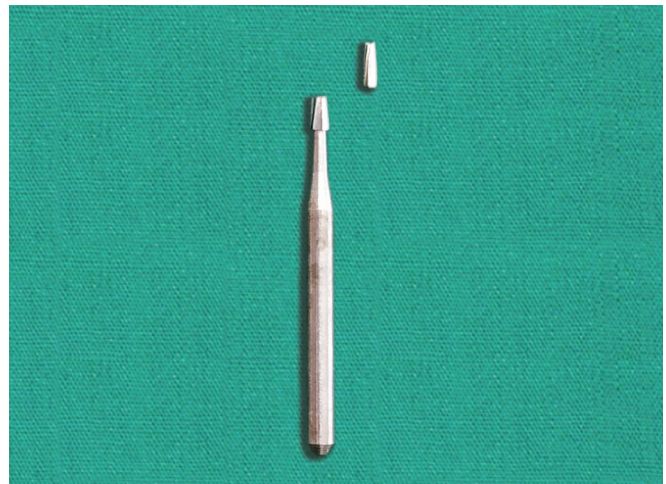
Fig. 14: Fractured bur with its fragment

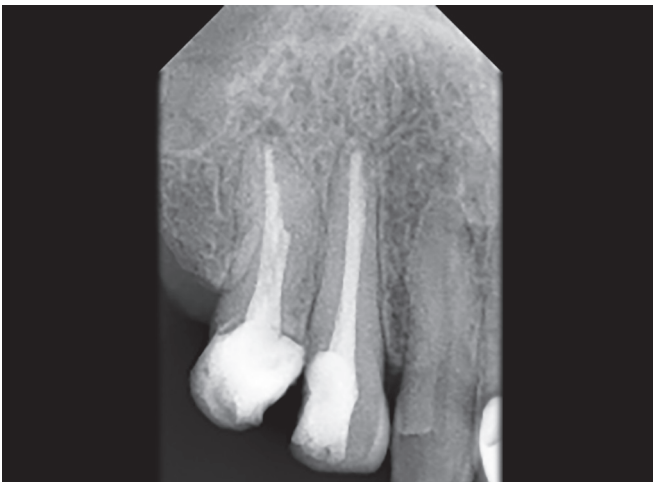
Fig. 15: Postobturation radiograph

the patency of the canal. Cleaning and shaping were performed manually, and obturation was performed with gutta-percha using cold lateral compaction technique and access cavity was restored with resin composite. Root canal treatment of 14 was completed on subsequent appointment (Fig. 15). The patient was asymptomatic during the 6-month follow-up period (Fig. 16). Unfortunately, patient failed to report for further follow-ups.

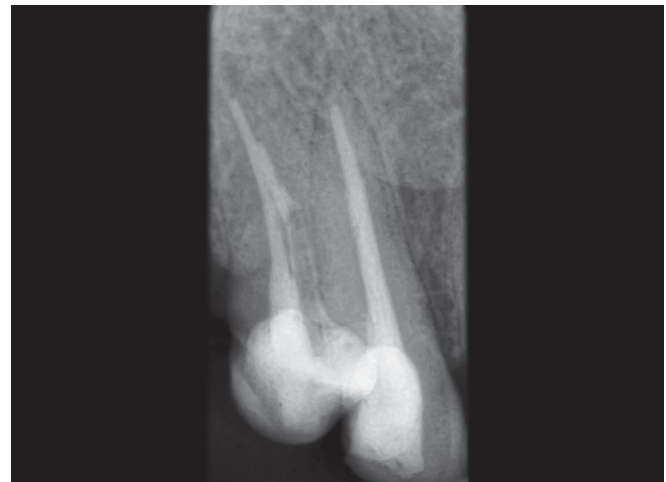
Fig 16: Six months follow-up
