CASE REPORT

Endodontic Management of a Cracked Tooth: A Case Report

Case description: A 67-year-old male patient reported pain in the upper left back tooth. On examination tooth-26 presented with a crack line in the palatal aspect. The case was diagnosed as pulp necrosis with symptomatic apical periodontitis in relation to 26 due to crack. The case was managed by sealing of crack, banding of the tooth, nonsurgical endodontic treatment, and a full metal crown.

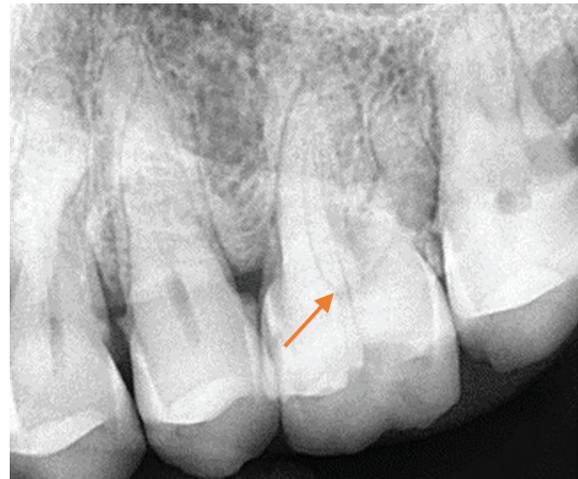
He had a class V glass ionomer restoration on a buccal surface of 26. On further examination, crack lines on the mesial and palatal aspects of the crown were seen. Tenderness on percussion and bite test had a positive response. A probing depth of 3 mm was present on the mesio-palatal aspect. Vitality test using electric pulp tester

Fig. 1: Preoperative radiograph showing extension of the crack line

revealed no response in 26. The case was diagnosed as pulp necrosis with symptomatic apical periodontitis-26 due to crack (Fig. 1).

The occlusal reduction was done before initiating root canal treatment on 26. On access opening, necrotic pulp tissue was present. After the extirpation of tissue, visual examination using a magnifying loupe with LED light was done. A palatal crack line was seen extending to the dentine terminating just above the pulp floor. There was another mesial crack line on the occlusal fourth of the mesial wall. The crack lines were removed using no: 1/4 round bur to a depth till crack lines were removed. Then the tooth was etched along the crack region and sealed with flowable composite resin restoration (COMPO-flo, D-tech). Banding was done using stainless steel band material (0.180" × 0.006"). Instrumentation of the canals was started with hand files with minimal force, followed by rotary instrumentation up to 25/4% Neoendo Flex files. Irrigation was done using 3% NaOCl solution and saline. Inter appointment intracanal calcium hydroxide medication was placed.

In the present case, the crack line was evident in the radiograph. The primary objective of the treatment plan was to stop the further propagation of the crack. This was achieved by reducing the occlusal height of the tooth, sealing of crack, and banding of the tooth using stainless steel band. Pane et al. have reported that stainless steel banding has the ability to reduce the cuspal flexure by

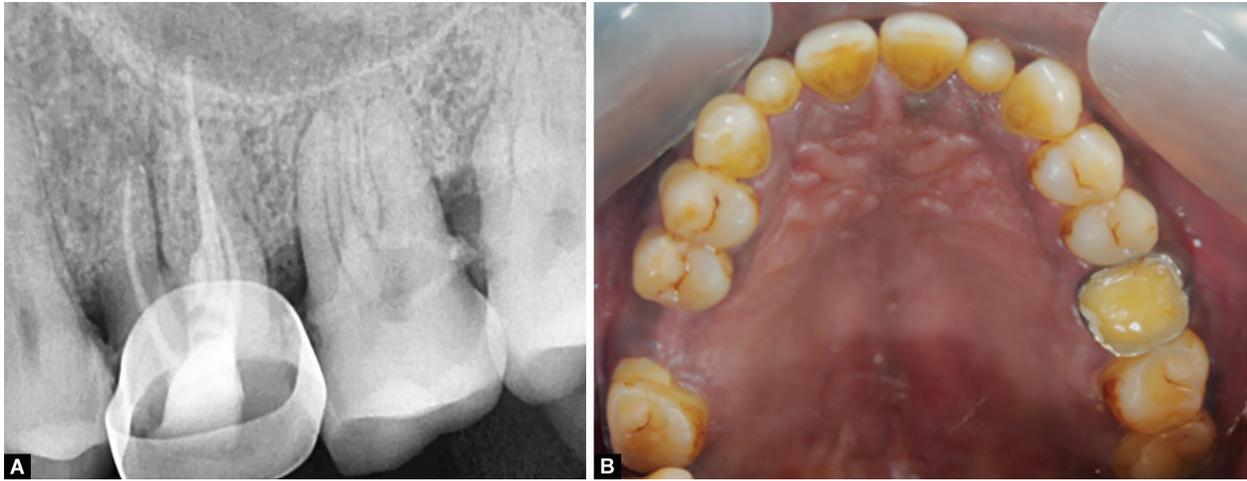
Figs 2A and B: Postoperative radiograph and photograph

Obturation was done using Gutta-percha and zinc oxide sealer by lateral condensation technique. Care was taken to apply minimal force during lateral condensation. Gutta-percha was sheared off at orifice level, and post-endodontic restoration was done using GIC liner, fiber-reinforced composite, and dentine bonding bulk-fill composite 1 week after obturation. After root canal treatment, follow-up evaluation was done at 1st and 3rd months. Clinical and radiographic evaluation revealed no pathologic changes. The band was removed by placing a groove along the welded line of the band using a diamond bur and splitting it. The tooth was prepared minimally, and prosthetic rehabilitation was done using a full metal crown. A review after 8 months showed asymptomatic and functional 26 with the intact periapical area (Figs 2 to 4).

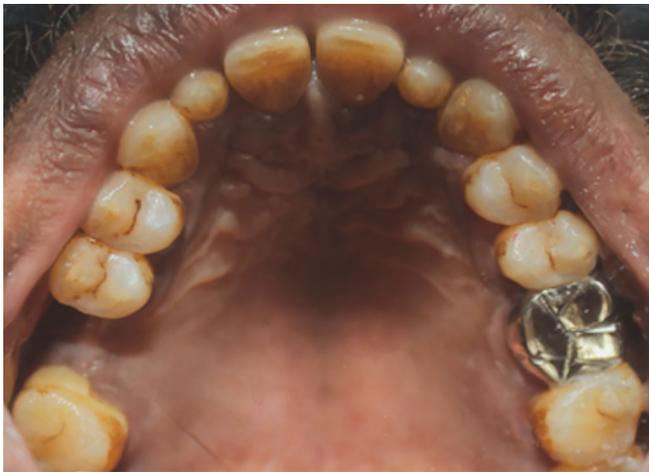
Fig. 3: After crown placement

In this case after banding and root canal treatment, the patient was relieved of symptoms. Post endodontic restoration was done by sealing the orifice using glass ionomer cement, replacing dentine with fiber-reinforced composite (EverX posterior, GC Europe), and occlusal laminate layer of nanohybrid composite (Tetric EvoCeram, Ivoclar Vivadent, Inc.). Bonded restorations have the potential to reinforce weakened tooth structures. Fiber-reinforced composite has high flexural strength and a lower percentage of shrinkage strain. It has the ability to arrest crack propagation. This short fiber-reinforced composite can structurally mimic dentin in its behavior under load. In addition, nanohybrid composite materials also have lower volumetric polymerization shrinkage stress. The banding was retained for a period of 1 month. The treatment was preceded by the placement of full metal crown. A full metal crown was opted because it requires minimal tooth reduction, thus preserving the bulk of tooth structure. Also, full coverage restoration binds the tooth together, providing an external compressive force like the banding and helps in uniform stress distribution. After root canal therapy, the survival rate of cracked teeth restored with a full crown is significantly higher than

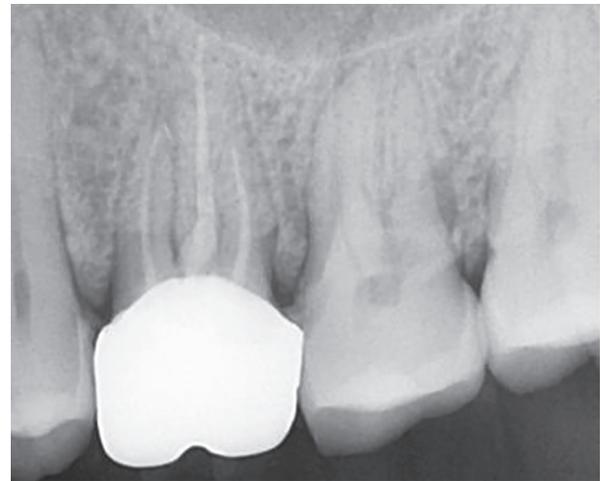
Fig. 4: Review after 8 months

A review after 8 months showed asymptomatic and functional tooth with intact periapex. Furthermore, the patient was advised to go for prosthetic rehabilitation of contralateral missing tooth-16.
